# OCEAN SQUARE, SAUNDERSFOOT

## Ground Investigation Geotechnical Report

**Report No. G40102      February 2018**

**Contract Name:** Ocean Square, Saundersfoot  
**Contract Reference:** G40102  
**Report Type:** Ground Investigation Report  
**Report Reference:** G40102/IR  
**Date of Report Production:** February 2018  
**Client:** Saundersfoot Harbour

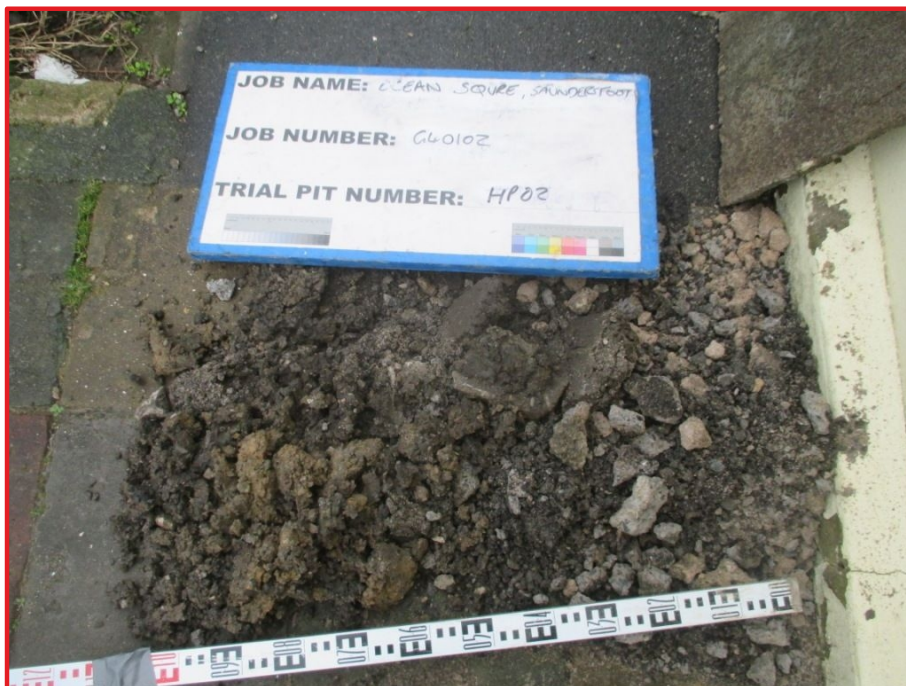
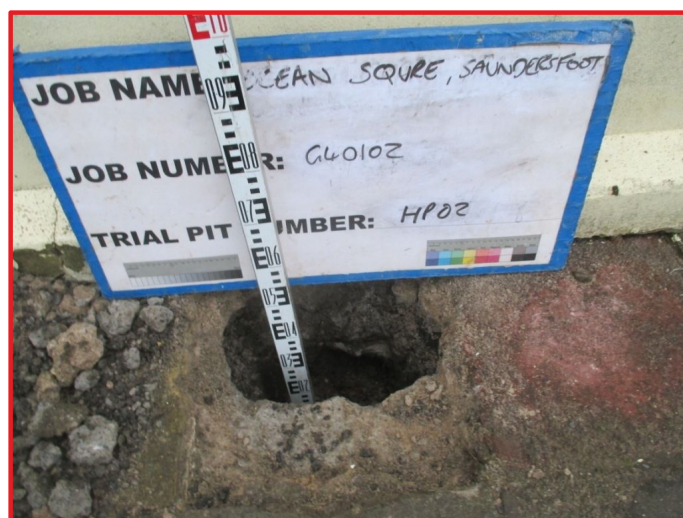
| <b>Contract : Ocean Square, Saundersfoot</b><br><b>Client : Saundersfoot Harbour</b> | | <b>Trial Pit No.</b><br><b>HP02</b> |

| <b>Contract : Ocean Square, Saundersfoot</b><br><b>Client : Saundersfoot Harbour</b> | | | | | | | <b>Trial Pit No.</b><br><b>HP02</b> | | |
|---|---|---|---|---|---|---|---|---|---|
| | | | | | 0.65 | Hand Pit terminated at 0.65mbgl foundations exposed | | 0.65 | |

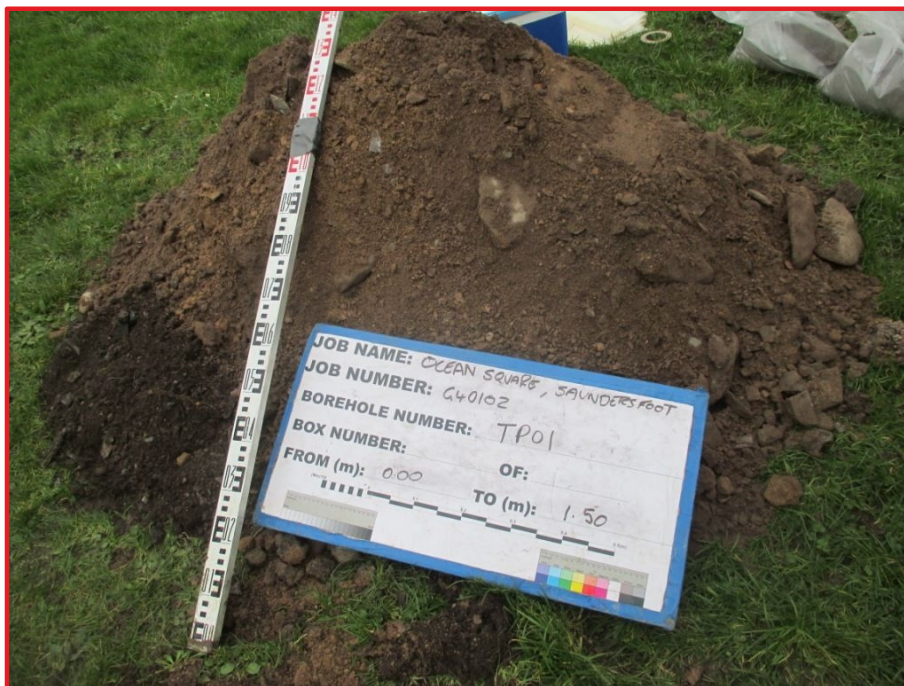
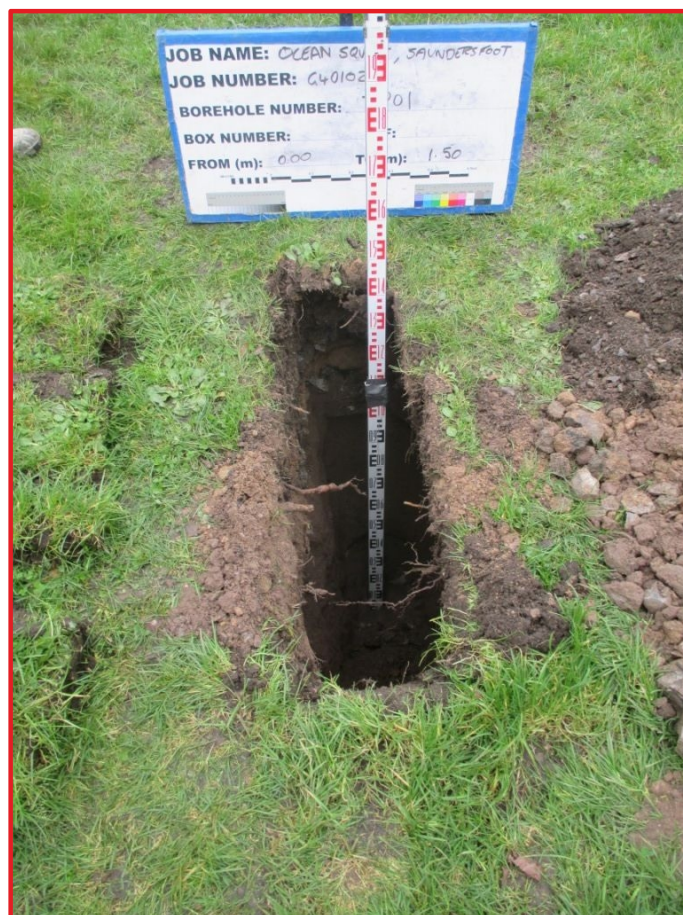
| <b>Contract : Ocean Square, Saundersfoot</b><br><b>Client : Saundersfoot Harbour</b> | | <b>Trial Pit No.</b><br><b>TP01</b> |

| <b>Contract : Ocean Square, Saundersfoot</b><br><b>Client : Saundersfoot Harbour</b> | | | | | | | <b>Trial Pit No.</b><br><b>TP01</b> | | |
|---|---|---|---|---|---|---|---|---|---|
| <b>PLAN</b><br> | | | Groundwater: No Groundwater Encountered<br><br>Stability: Unstable collapsing sides<br><br>Shoring: N/A | | | Remarks : Soakaway attempted within trial pit.<br>Failed due to rapid out flow, unable to fill pit. | | | |
